### NORTHRIDGE EARTHQUAKE

## **Turning Loss to Gain**

Seismic Safety Commission State of California

SSC Report No. 95-01 Sacramento, California, 1995

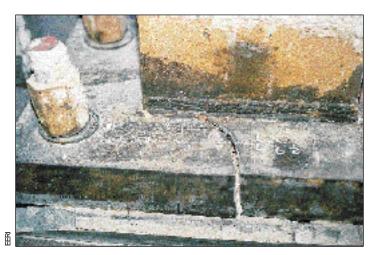
Figure 15. A 4-inch-thick steel plate supporting the base of a column at the Oviatt Library at CSU Northridge. The plate fractured when the building was violently shaken.

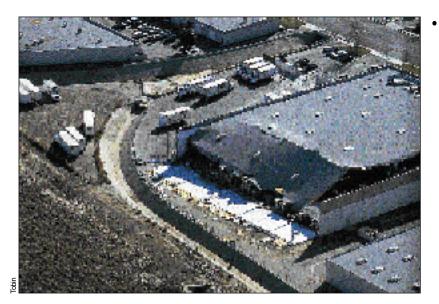
Figure 22. This industrial tilt-up building had its roof and wall partially collapse.

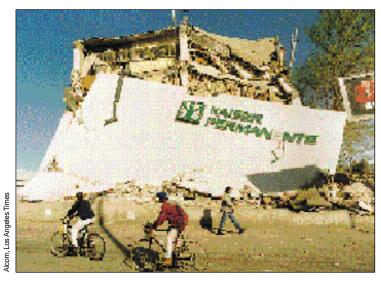
Figure 33. Both ends of this 1960s medical office building collapsed and the second floor "pancaked." Fortunately it was not occupied.

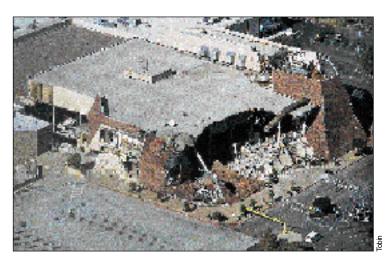
Figure 34. If buildings such as this had been occupied, hundreds would likely have been killed during the Northridge earthquake. This building was incompletely retrofitted after the 1971 earthquake, which may have hastened its demise in this event.

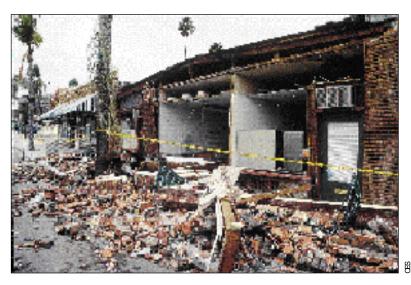
A number of engineers and building officials attribute much of the significant damage to poor

design and construction, not to the code itself. Some investigators reported that the damage in retrofitted URMs appeared to be in large part caused by design or plan check errors and lack of adequate quality control, citing numerous instances where unbonded brick veneer was incorrectly used in calculations of wall height-tothickness ratios. There were also reports of buildings that appeared to have low mortar strength but were assigned much higher values by the original testing laboratory and reports of drawings that did not conform to the buildings being strengthened. In addition to stating that quality control was a more severe problem than the Division 88 standards, a city task force also recommended a number of specific code changes. The fact of the matter remains that URM buildings are brittle, vulnerable structures, and the degree to which seismic improvements can be made is limited by economic feasibility.

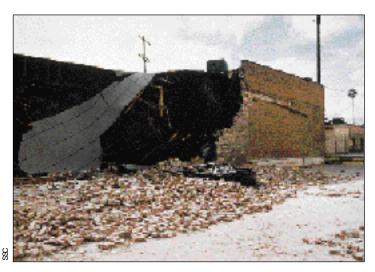
Figure 37. This retrofitted brick building collapsed in part because its wall braces were ineffective.

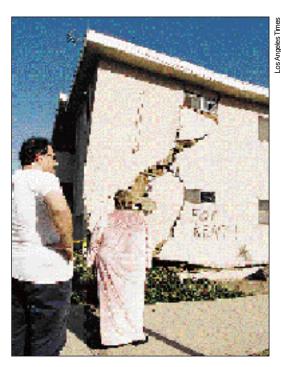
Figure 46. Damage to apartments caused more life and housing losses than other building types in this earthquake.

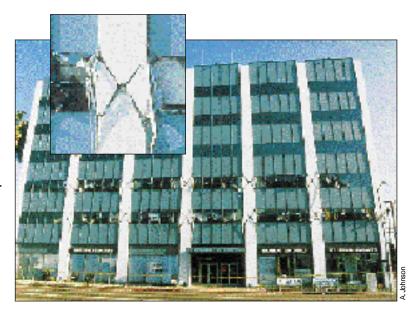
Figure 53. This office building's exterior cladding affected the way its frame responded to shaking, finally resulting in column failure and demolition. *Inset*, detail.

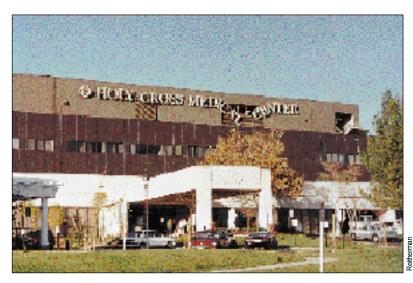
Figure 57. Damage to the heating and ventilation system in this hospital shut it down for a week. Months later, additional structural damage to steel connections was discovered and repaired.

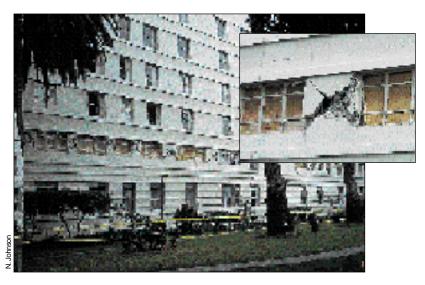
Figure 58. This older hospital was severely damaged. Lightly reinforced concrete walls lost much of their strength when X cracks formed. *Inset*, detail.

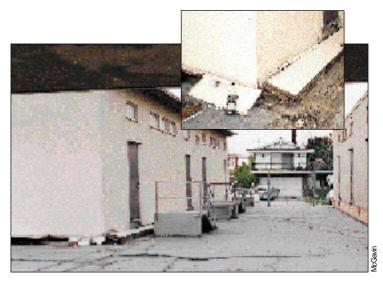
Several portable or relocatable classroom buildings were seriously damaged in the earthquake. Many units had foundation failures where the cripple walls were racked up to eight inches out of plumb. Some fell to the ground. These failures occurred in structures constructed prior to 1976 with wood foundations. Some were poorly maintained and showed evidence of rotting wood and a subsequent loosening of nails intended to resist seismic forces. See Figure 62.

Figure 62. Several portable classrooms were seriously damaged after falling from weak or poorly maintained foundations. *Inset*. detail.

- Legislation be enacted to require public school districts and community colleges to attach portable classrooms to foundations and abate life-threatening nonstructural hazards as proposed by DSA.
- The DSA Field Act Advisory Board work with DSA to develop appropriate legislative language and implementing regulations.

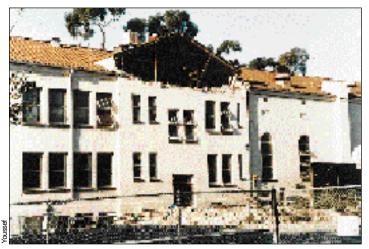
Figure 66. Life-threatening structural hazards such as this are still allowed in older private schools throughout California. Most of them have been eliminated in our public schools.
